**Flood Control Project Maintenance  
Levee Inspections**

**Fall 2012 Levee Maintenance Deficiency Summary Report**

**Sutter Maintenance Yard Maintenance Area 0016**

Waterway			Bank	Unit Miles
Unit No. 01 Feather River			Right	4.09
	Spring (March - May)	Summer (June - August)	(September - November) Fall	Winter (December - February)
Unit Maintenance Rating (Fall Only)			A	
Date of Inspection	03/28/2012 - 03/28/2012		09/25/2012 - 09/25/2012	
DWR Inspector	Clay Thomas		Clay Thomas	
Accompanied By	Jason Cooper		Jason Cooper

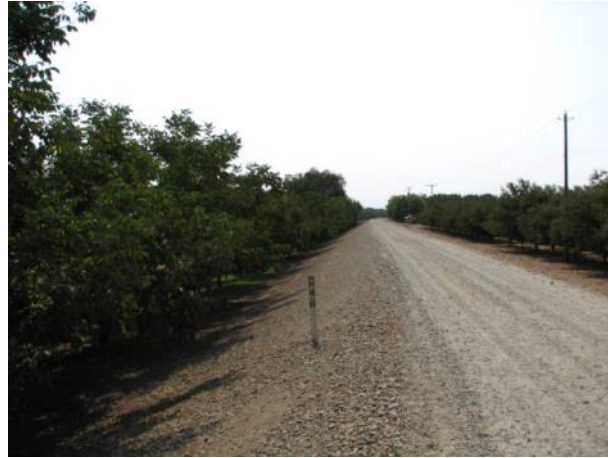
Levee Mile Report Line	1
Start Levee Mile	0.01
End Levee Mile	4.08
Location	Water Side
Category	Earthen Levee
Item	Vegetation

This photo is of the waterside slope of the levee at levee mile 4.06.

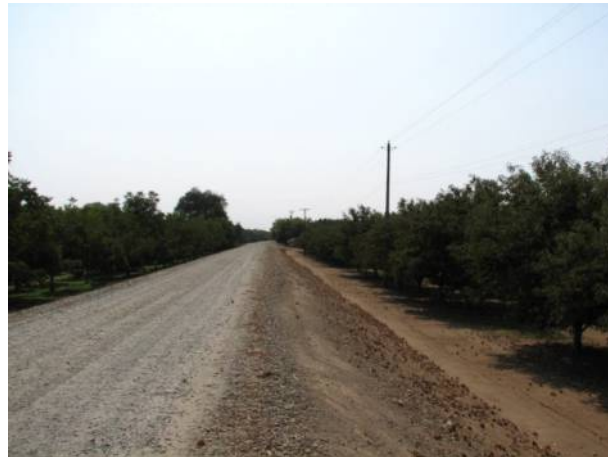
Levee Mile Report Line	2
Start Levee Mile	0.01
End Levee Mile	4.08
Location	Land Side
Category	Earthen Levee
Item	Vegetation

This photo shows the landside slope of the levee at levee mile 4.06.

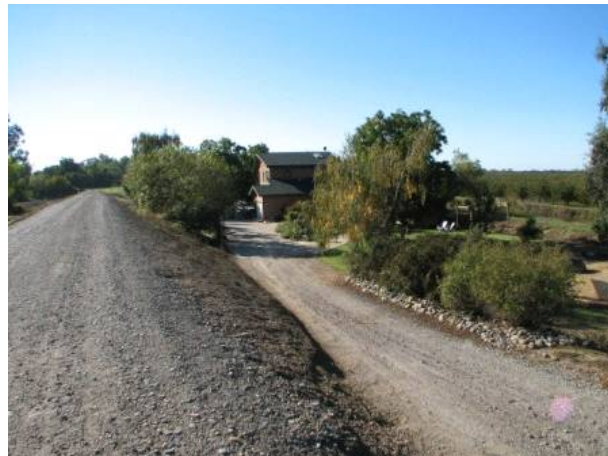
Levee Mile Report Line	3
Start Levee Mile	0.06
End Levee Mile	0.10
Location	Land Side
Category	Earthen Levee
Item	Vegetation

Levee mile 0.10. This photo shows the landscaping on the landside slope and toe.

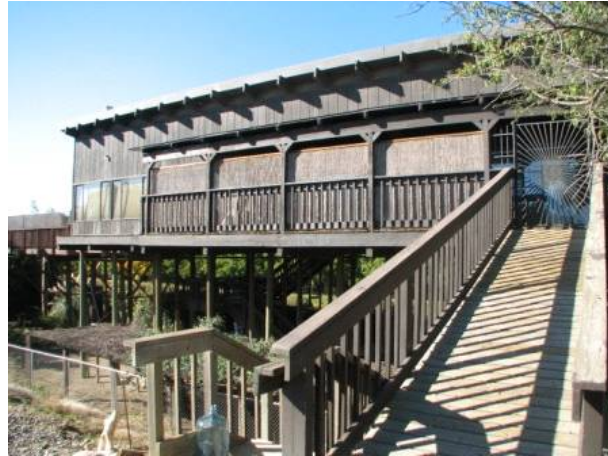
Levee Mile Report Line	4
Start Levee Mile	0.18
End Levee Mile	0.18
Location	Land Side
Category	Earthen Levee
Item	Encroachments

Levee mile 0.18. This photo shows the building on the landside shoulder and toe.

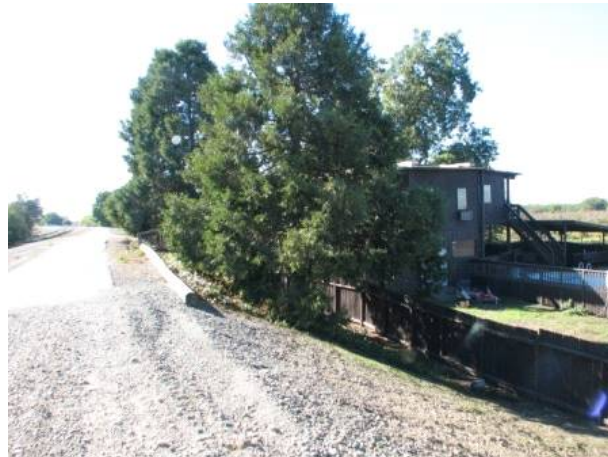
Levee Mile Report Line	6
Start Levee Mile	0.45
End Levee Mile	0.49
Location	Land Side
Category	Earthen Levee
Item	Encroachments

DWR ID: DWR_MA0016_01_s_2012_5										
6	0.45	0.49	Earthen Levee	Encroachments	LS En	U	BU : Building	39.262213 ° -121.636545 °	39.262825 ° -121.636430 °	7 Y
DWR ID: DWR_MA0016_01_s_2012_7										
7	2.85	3.08	Earthen Levee	Encroachments	LS En	M	DT : Ditch	39.293675 ° -121.636615 °	39.296748 ° -121.638192 °	14 Y
DWR ID: DWR_MA0016_01_s_2012_14

Levee mile 0.49. This photo shows the building and landscaping on the landside slope and toe.

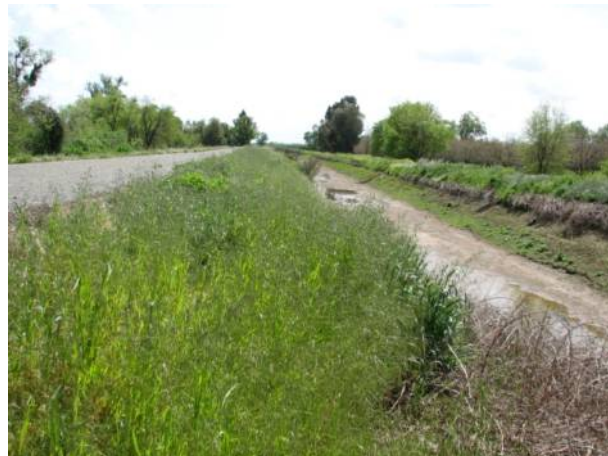
Levee Mile Report Line	7
Start Levee Mile	2.85
End Levee Mile	3.08
Location	Land Side
Category	Earthen Levee
Item	Encroachments

Land side ditch levee mile 3.08.

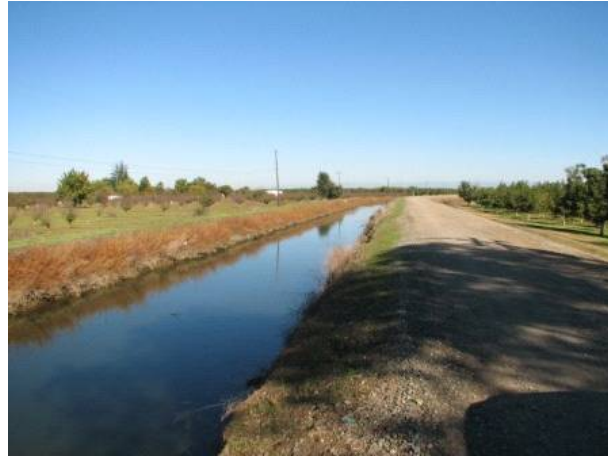
Levee Mile Report Line	7
Start Levee Mile	2.85
End Levee Mile	3.08
Location	Land Side
Category	Earthen Levee
Item	Encroachments

AG ditch land side slope and toe.
